# **Single-Event Effect Report for EPC Series eGaN FETs: EPC1001, EPC1010, EPC1014, EPC1012**

Leif Scheick, Ph.D.  
Jet Propulsion Laboratory  
Pasadena, California

JPL Publication 13-4 2/13

NASA Electronic Parts and Packaging (NEPP) Program  
Office of Safety and Mission Assurance

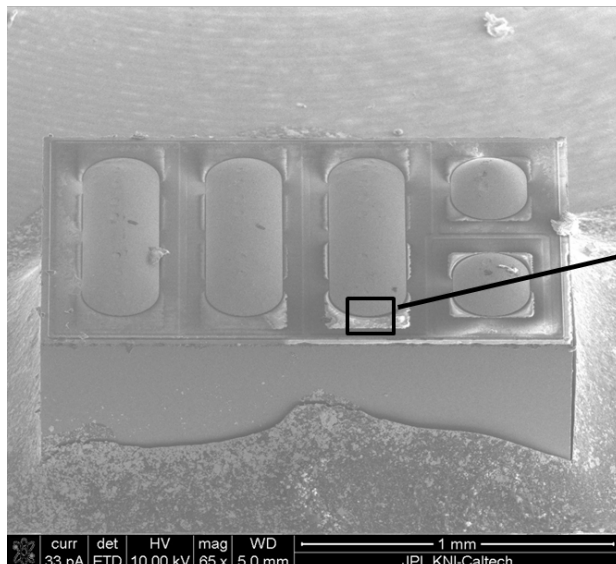
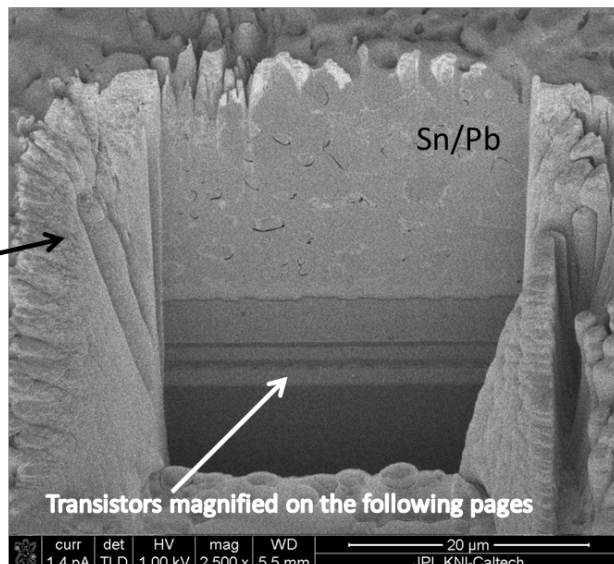
**Figure 3-4. EPC1014 before and after FIB.**

**SEM Micrograph, 65X ,  
52 deg. Tilt**

**SEM Micrograph after FIB Cut,  
2500X, 52 deg. Tilt**

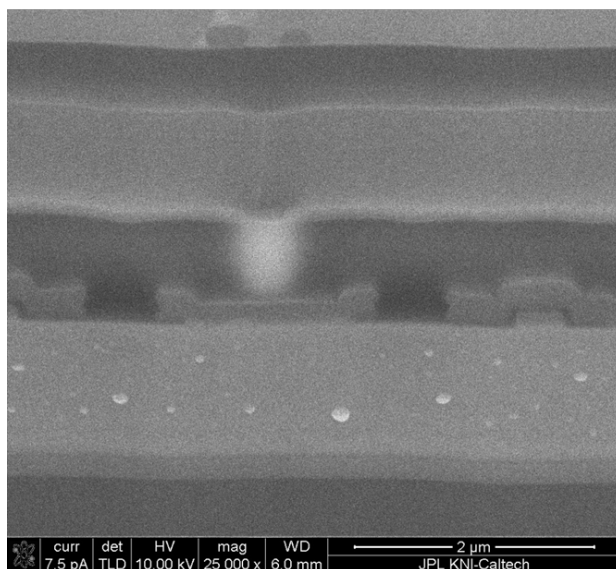
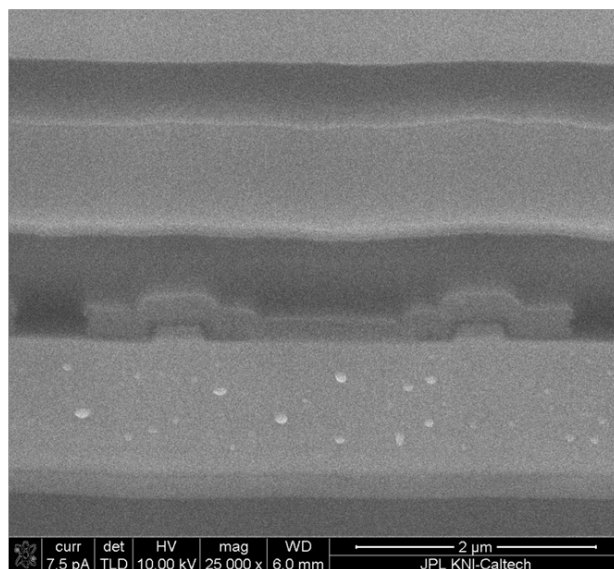
**Figure 3-5. SEM of the active areas of the DUT (Note the tungsten plug on the left).**

**SEM Micrograph after FIB Cut,  
25,000X , 52 deg. Tilt**

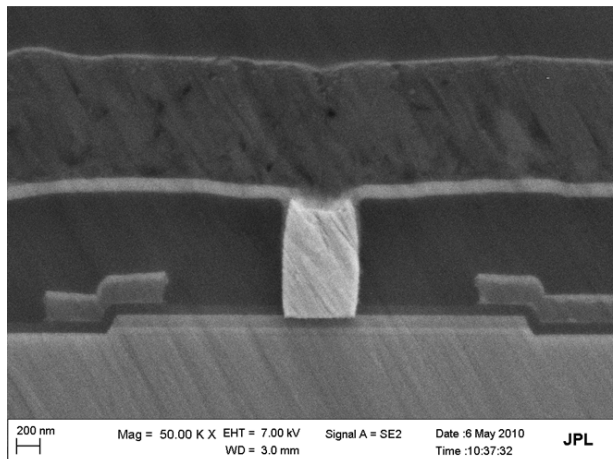
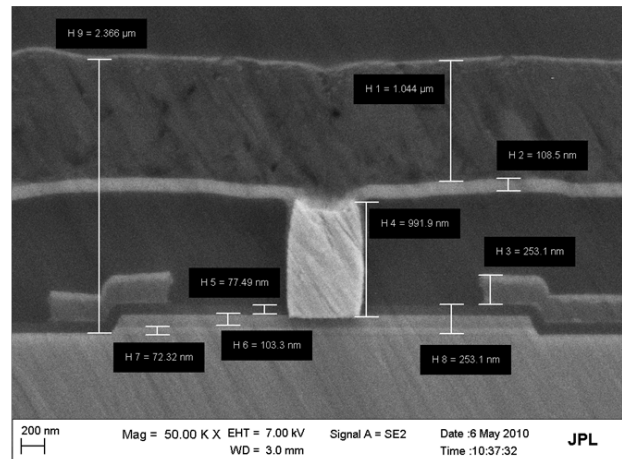
Figure 3-7. Analysis of the tungsten plug.

SEM Micrograph after Mechanical cross-section, 50KX

SEM Micrograph after Mechanical cross-section, 50KX with Lateral dimensions

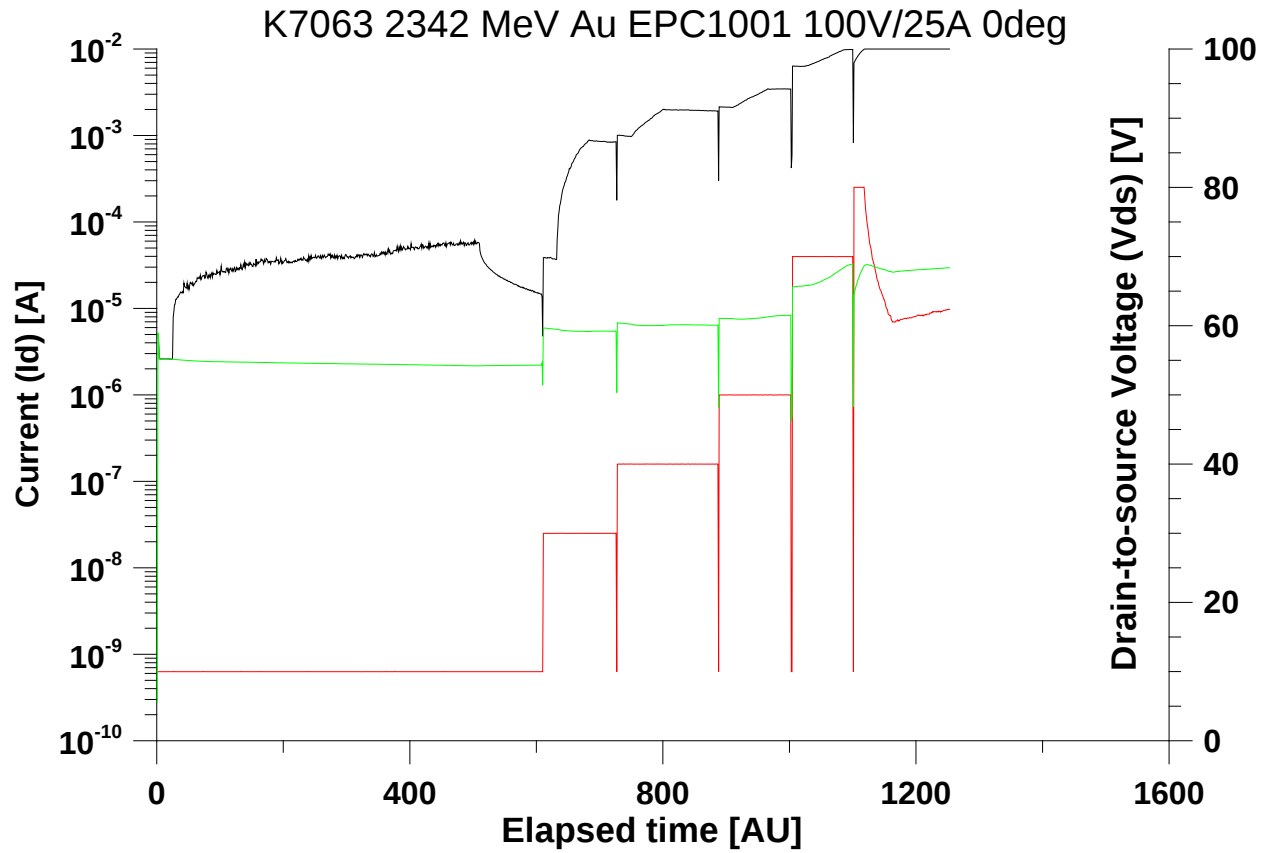
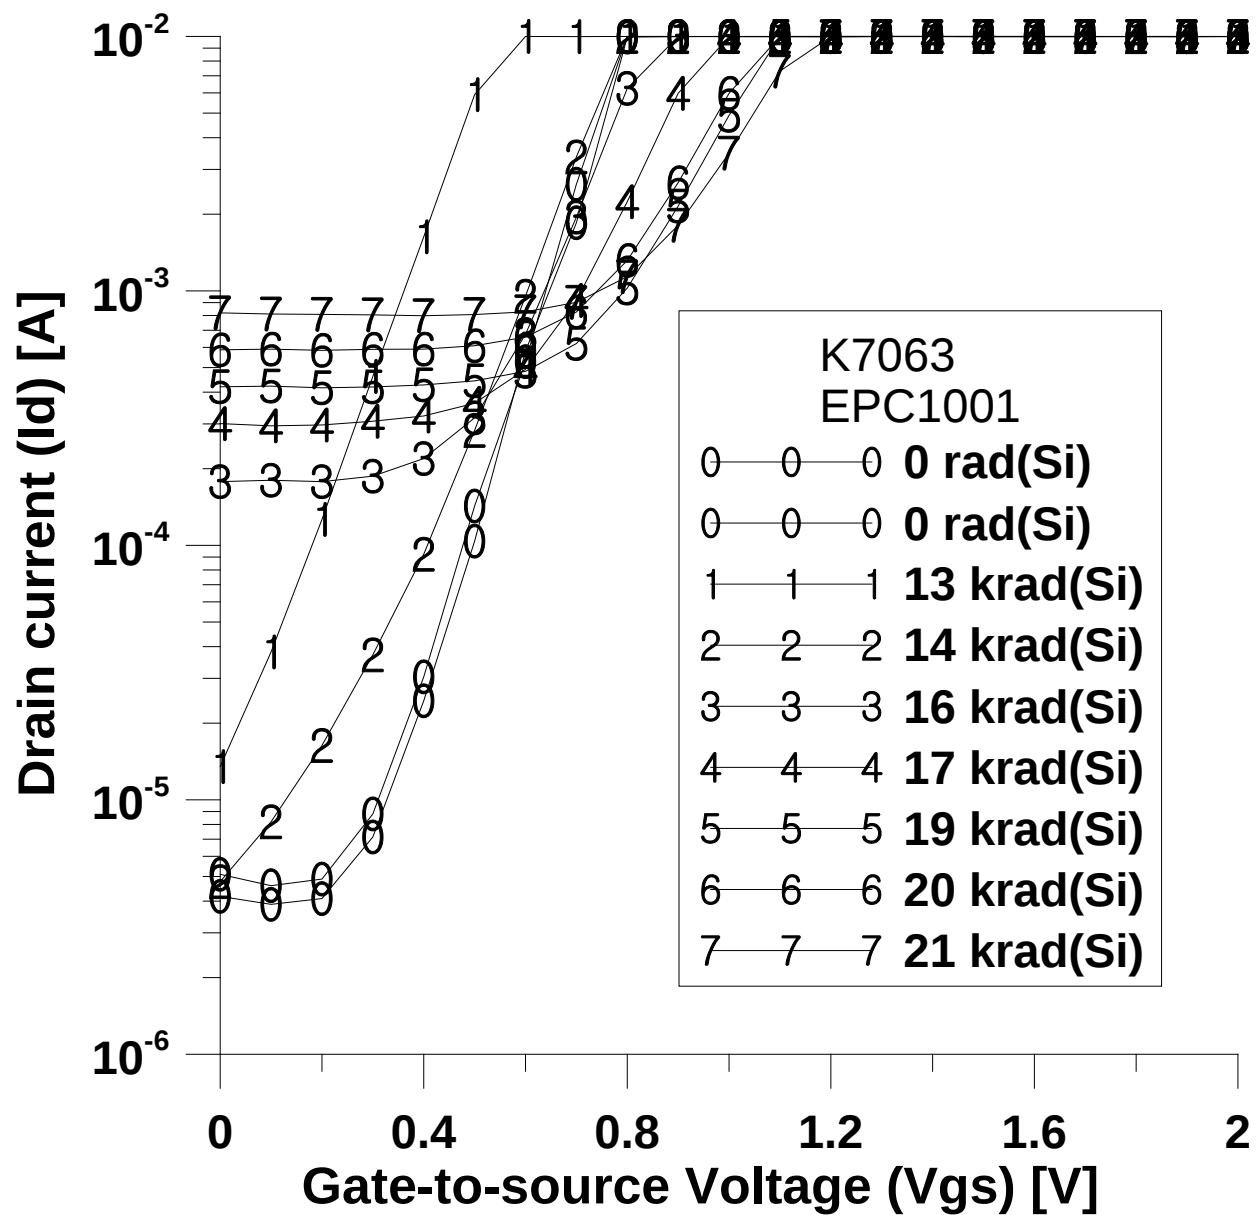
Fig. 9.1 and 9.2 present part K7063, EPC1001.

**Figure 1.1-1.** Heavy ion response of the EPC1001, K7063. Ion flux was  $1\text{E}5\text{ cm}^{-2}\text{-s}^{-1}$ . The first irradiation was  $1\text{E}7\text{ cm}^{-2}$ , the rest were for  $1\text{E}6\text{ cm}^{-2}$ . Red line is drain voltage; gate voltage is zero volts. Black line is drain current and green line is gate current.

Figure 1.1-1. Effect of heavy ion radiation on the transfer curve of part K7063. Drain voltage was 10 V.

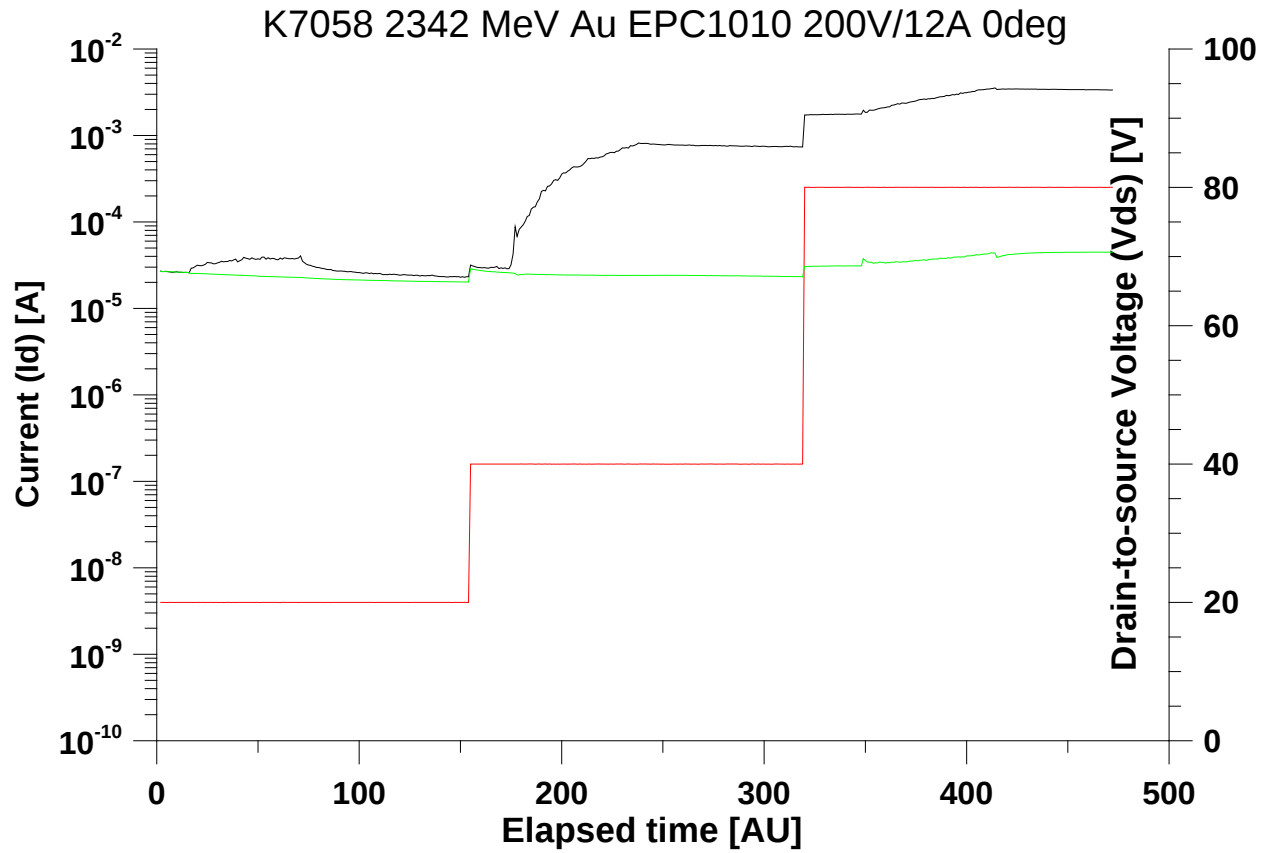
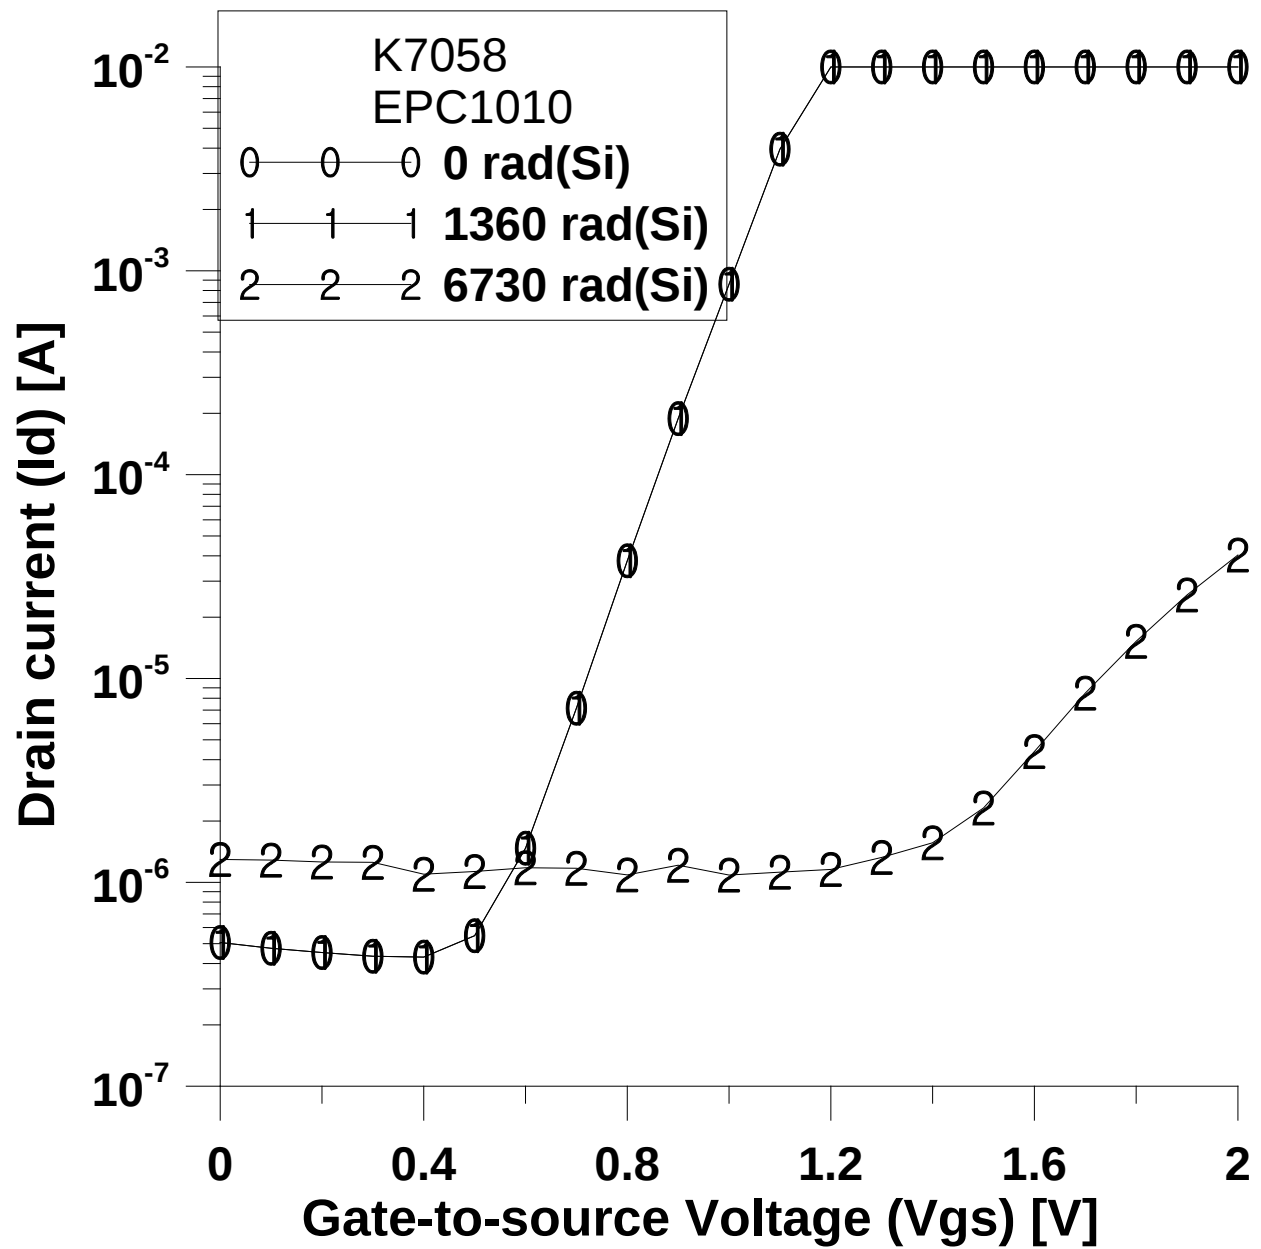
Fig. 9.3 and 9.4 present part K7058, EPC1010.

**Figure 1.1-1.** Heavy ion response of the EPC1010 200V/12A. Ion flux was  $1\text{E}5 \text{ cm}^{-2}\text{-s}^{-1}$ . Red line is drain voltage; gate voltage is zero volts. Black line is drain current and green line is gate current.

**Figure 1.1-1.** Effect of heavy ion radiation on the transfer curve K7058. Drain voltage was 10 V.

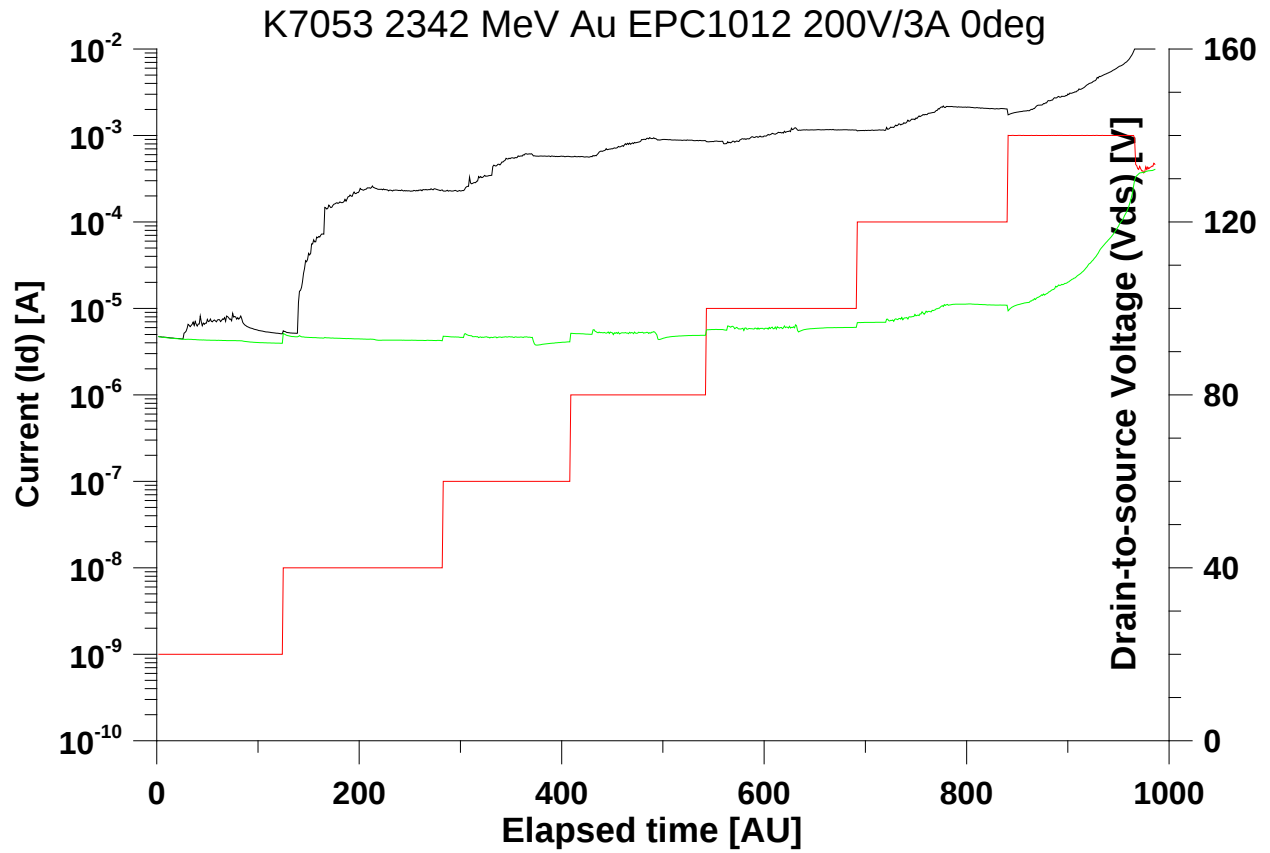
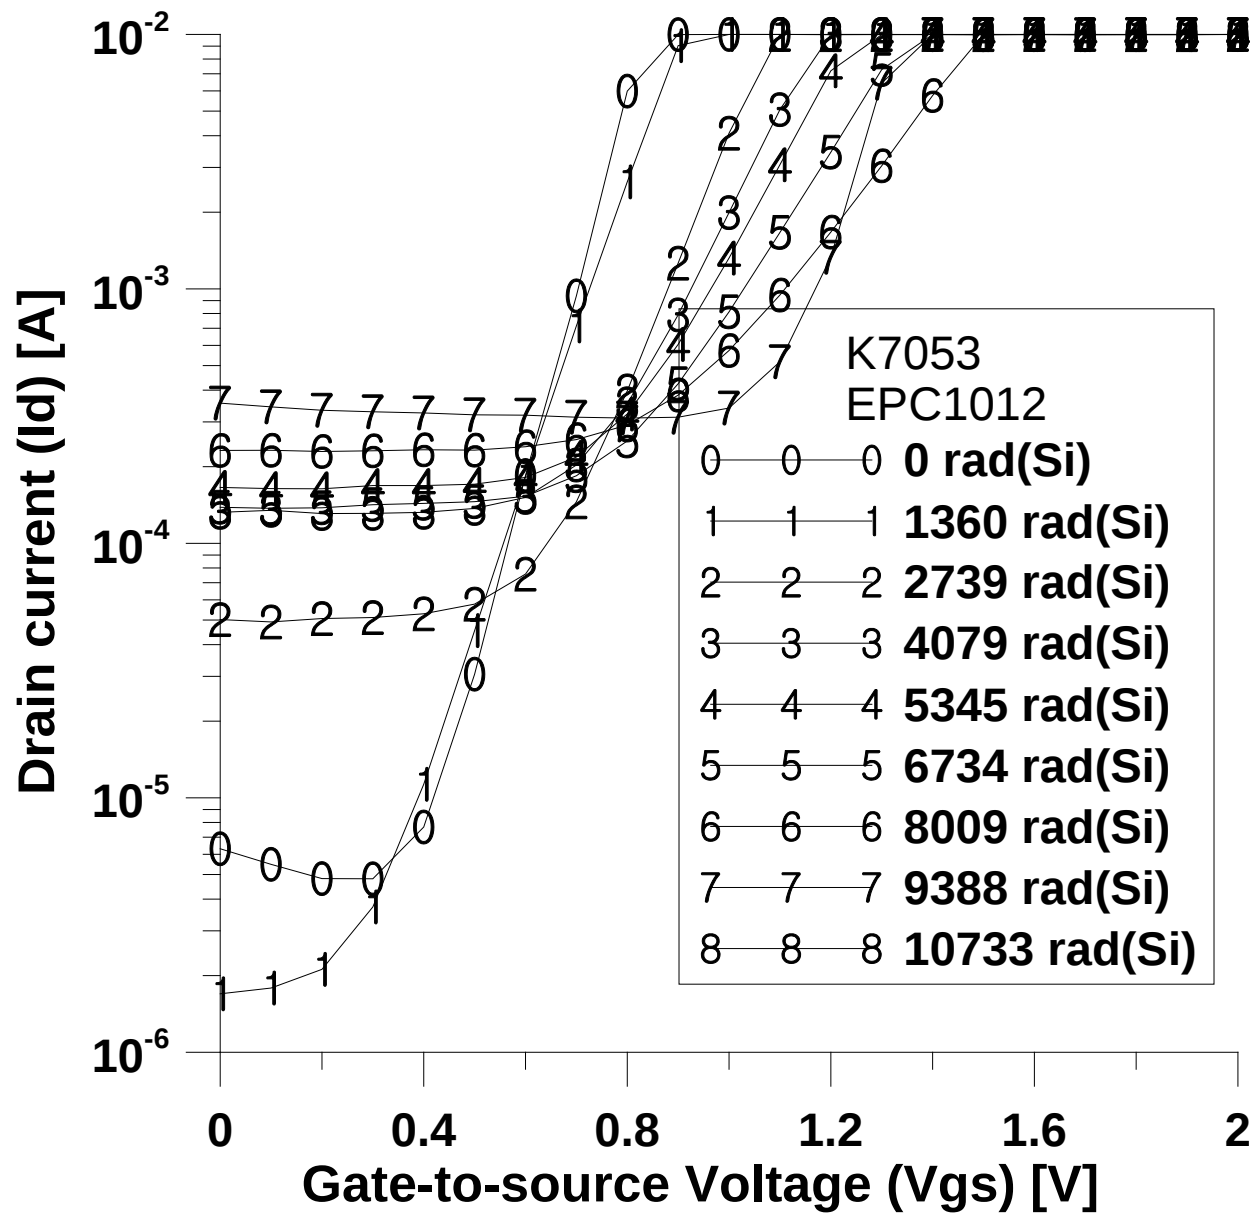
Fig. 9.5 and 9.6 present part K7053, EPC1012.

**Figure 1.1-1.** Heavy ion response of the EPC1012 200V/3A. Ion flux was  $1\text{E}5 \text{ cm}^{-2}\text{-s}^{-1}$ . Red line is drain voltage; gate voltage is zero volts. Black line is drain current and green line is gate current.

Figure 1.1-1. Effect of heavy ion radiation on the transfer curve K7053. Drain voltage was 10 V.

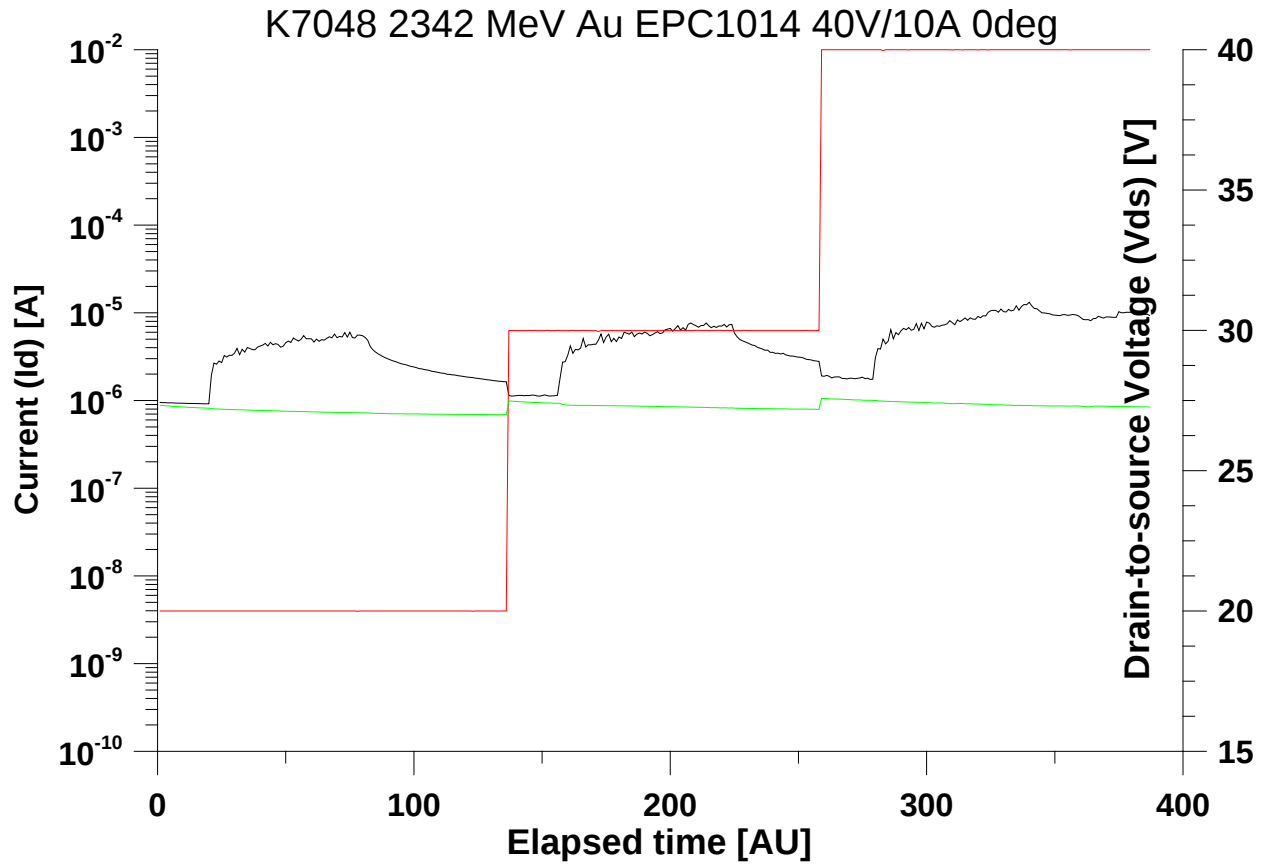
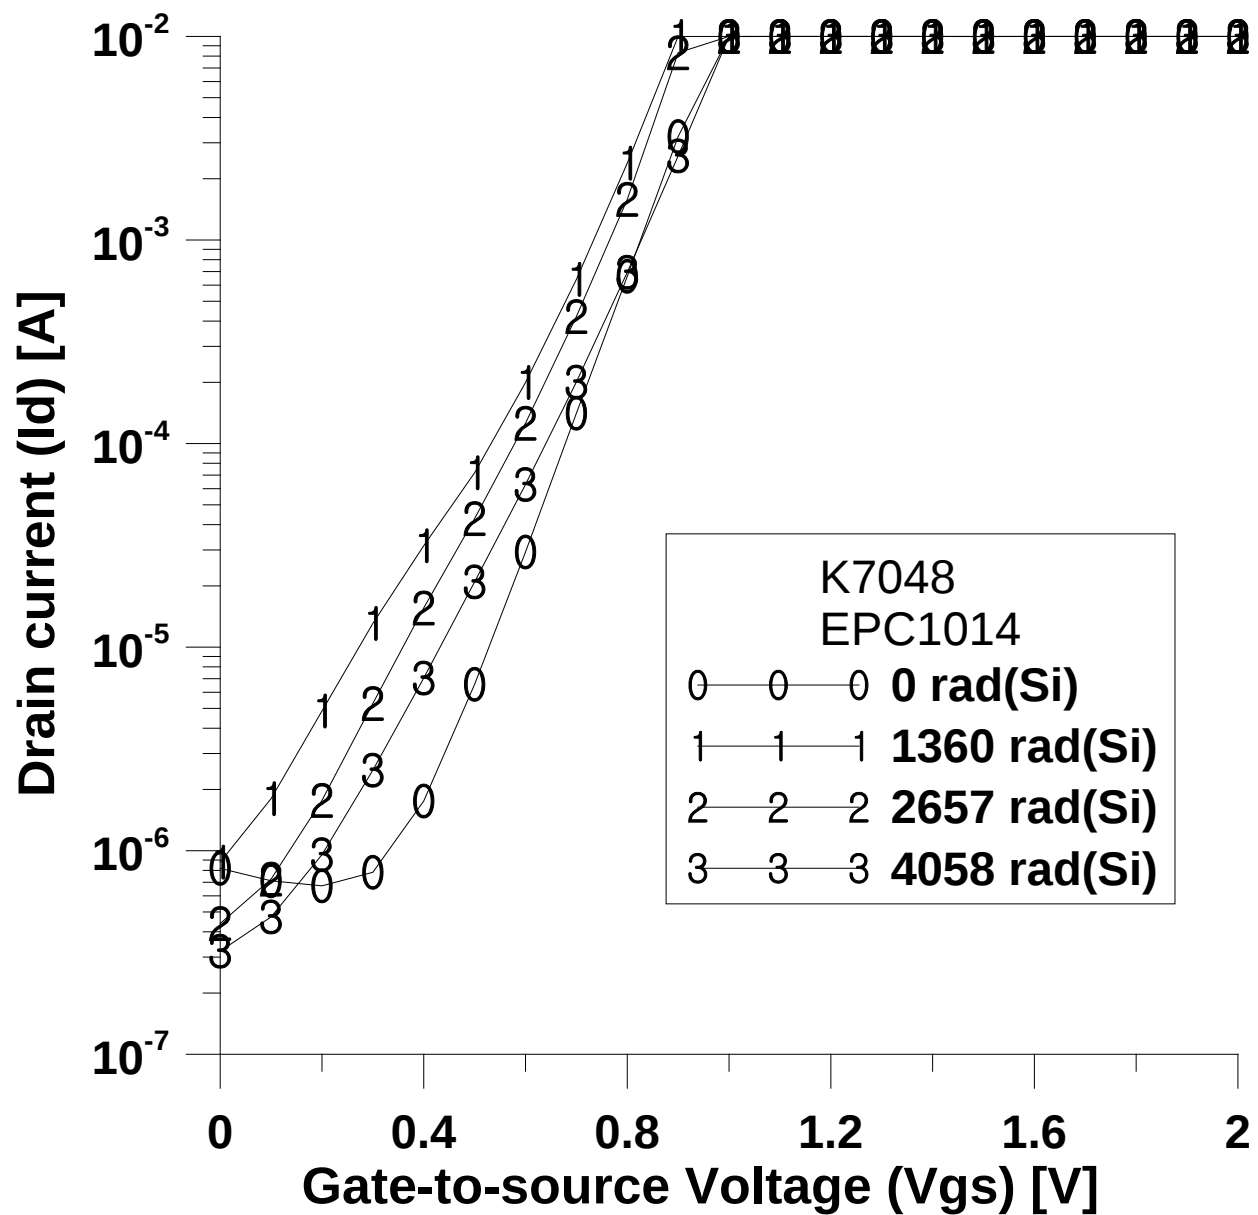
Fig. 9.7 and 9.8 present part K7048, EPC1014.

Figure 1.1-1. Heavy ion response of the EPC1014 40V/10A. Ion flux was  $1E5 \text{ cm}^{-2}\text{-s}^{-1}$ . Red line is drain voltage; gate voltage is zero volts. Black line is drain current and green line is gate current.

Figure 1.1-1. Effect of heavy ion radiation on the transfer curve K7048. Drain voltage was 10 V.

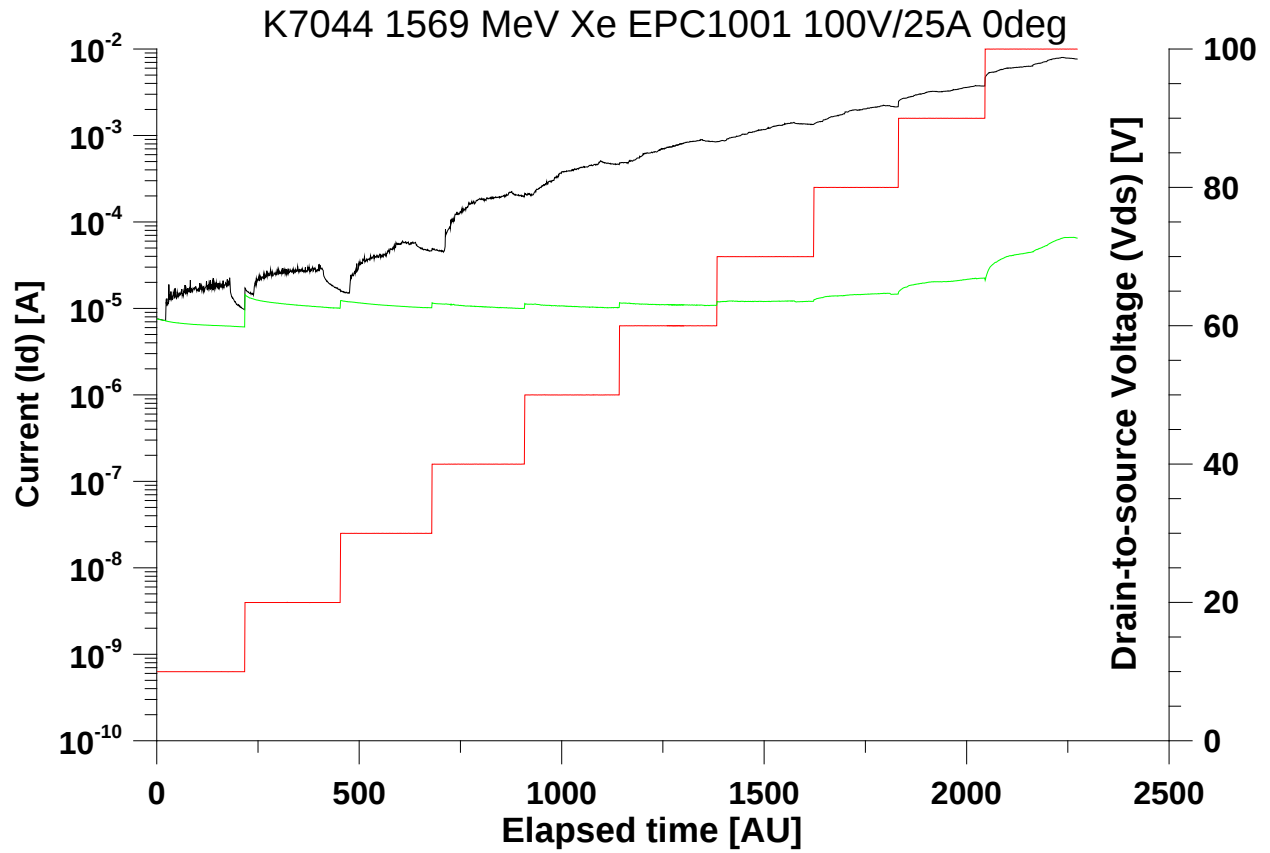
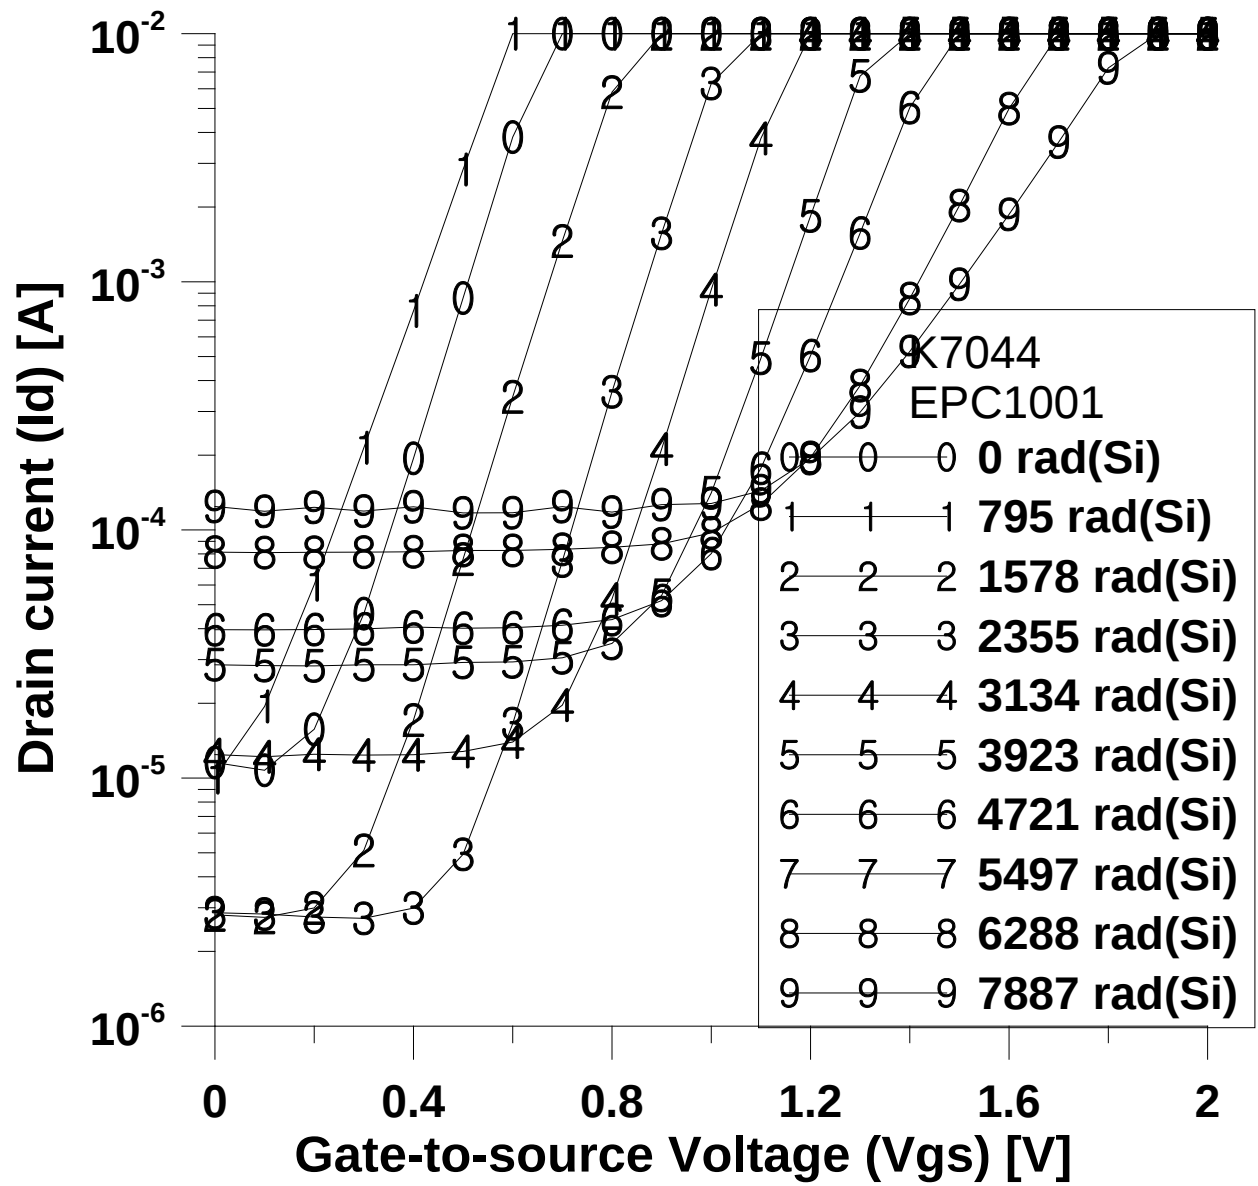
Fig. 9.9 and 9.10 present part K7044, EPC1001.

**Figure 1.1-1.** Heavy ion response of the EPC1001 100V/25A. Ion flux was  $3E4 \text{ cm}^{-2}\text{-s}^{-1}$ . Red line is drain voltage; gate voltage is zero volts. Black line is drain current and green line is gate current.

Figure 1.1-1. Effect of heavy ion radiation on the transfer curve K7044. Drain voltage was 10 V.

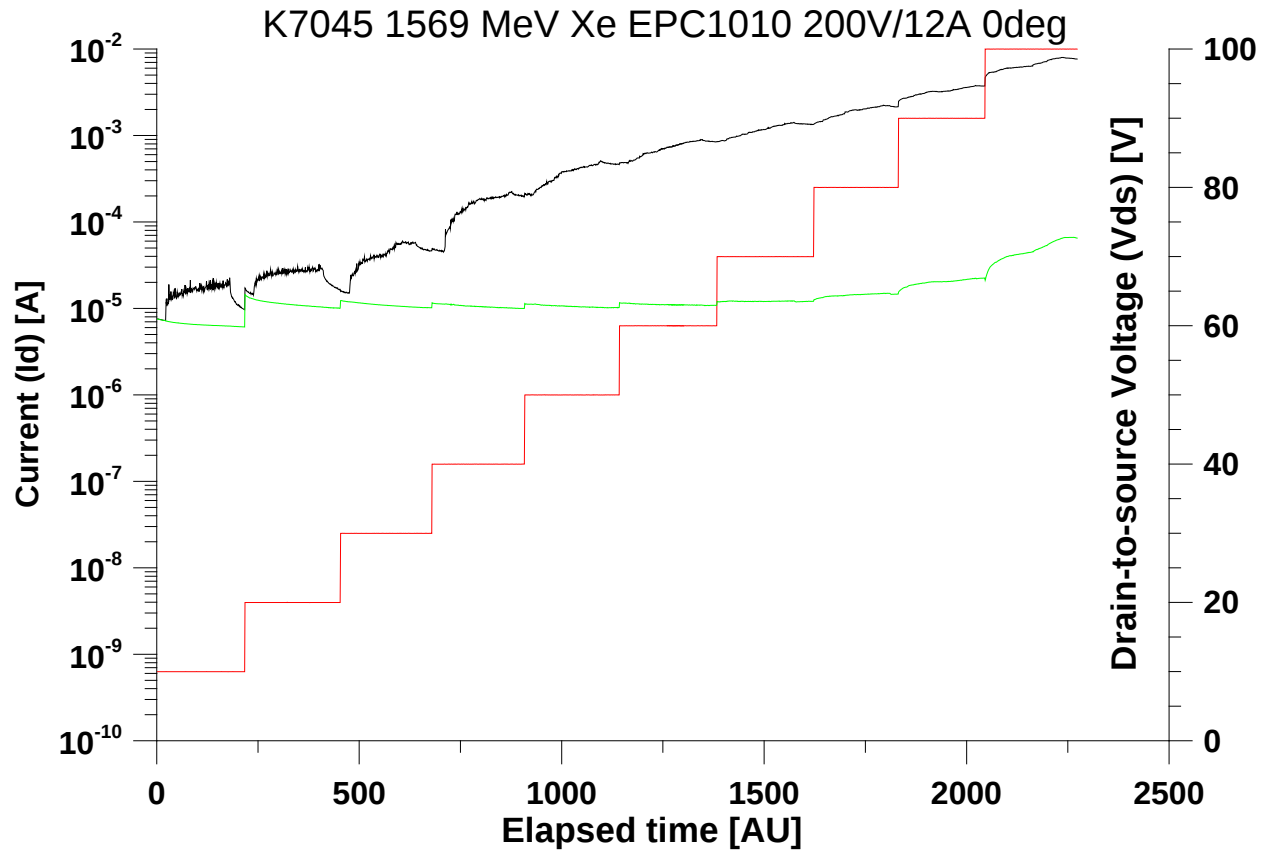
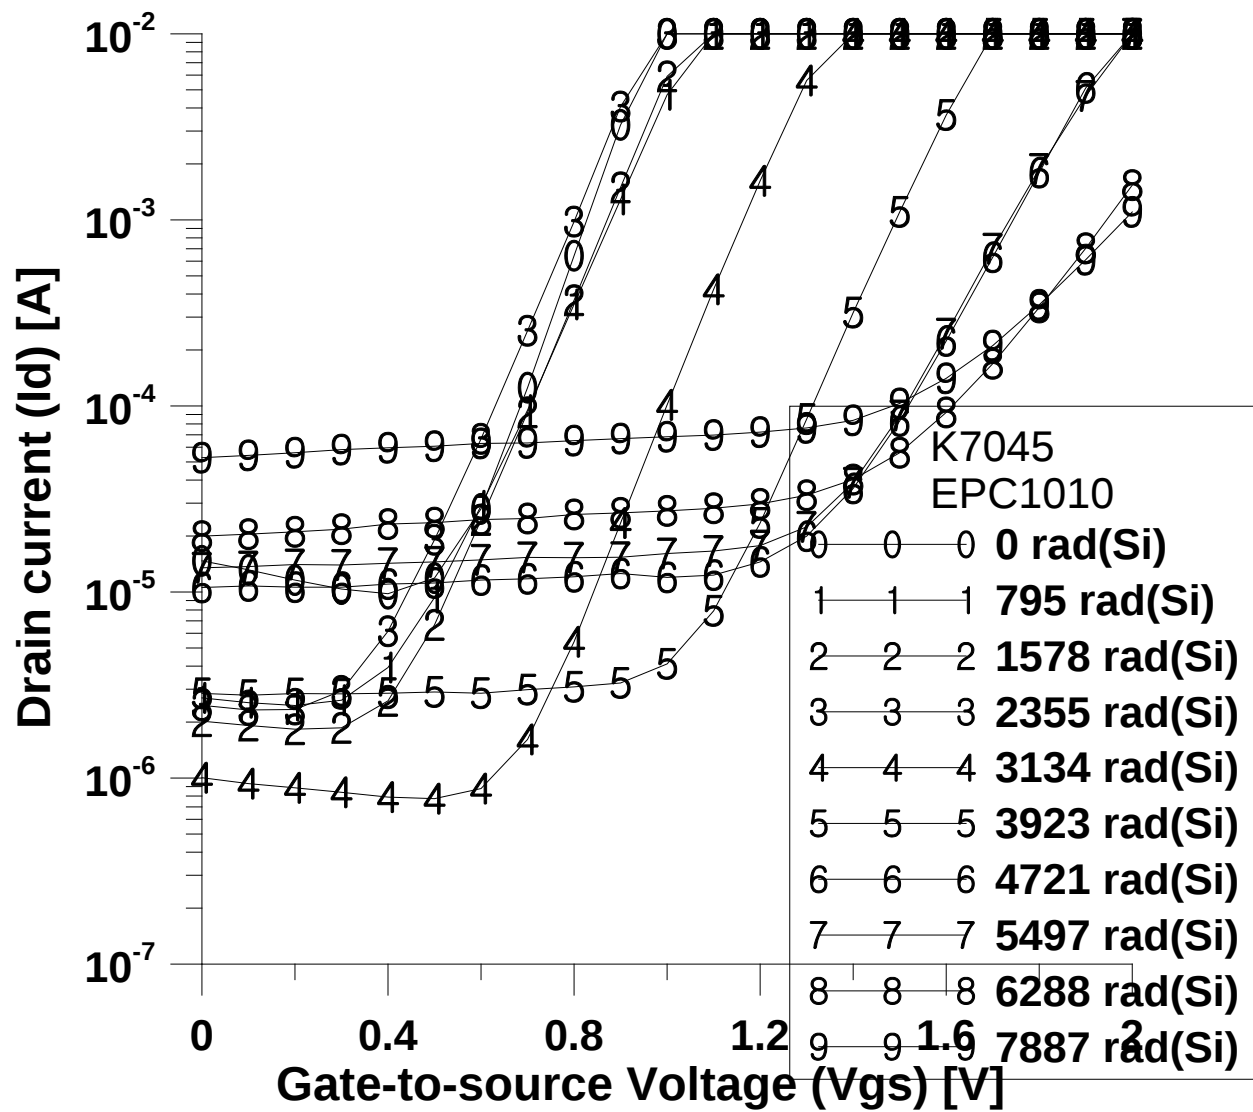
Fig. 9.11 and 9.12 present part K7045, EPC1010.

**Figure 1.1-1.** Heavy ion response of the EPC1010 200V/12A. Ion flux was  $3E4 \text{ cm}^{-2}\text{-s}^{-1}$ . Red line is drain voltage; gate voltage is zero volts. Black line is drain current and green line is gate current.

**Figure 1.1-1.** Effect of heavy ion radiation on the transfer curve K7045. Drain voltage was 10 V.

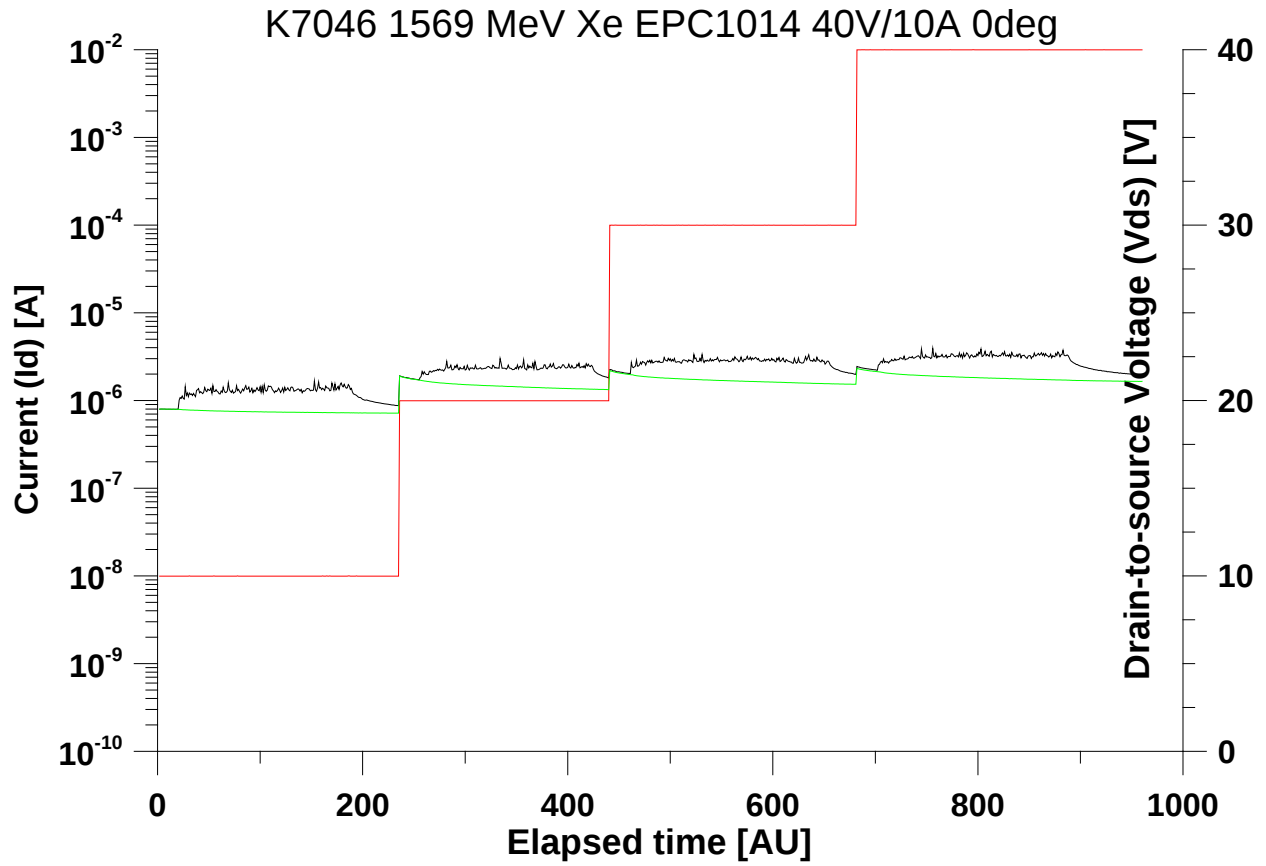
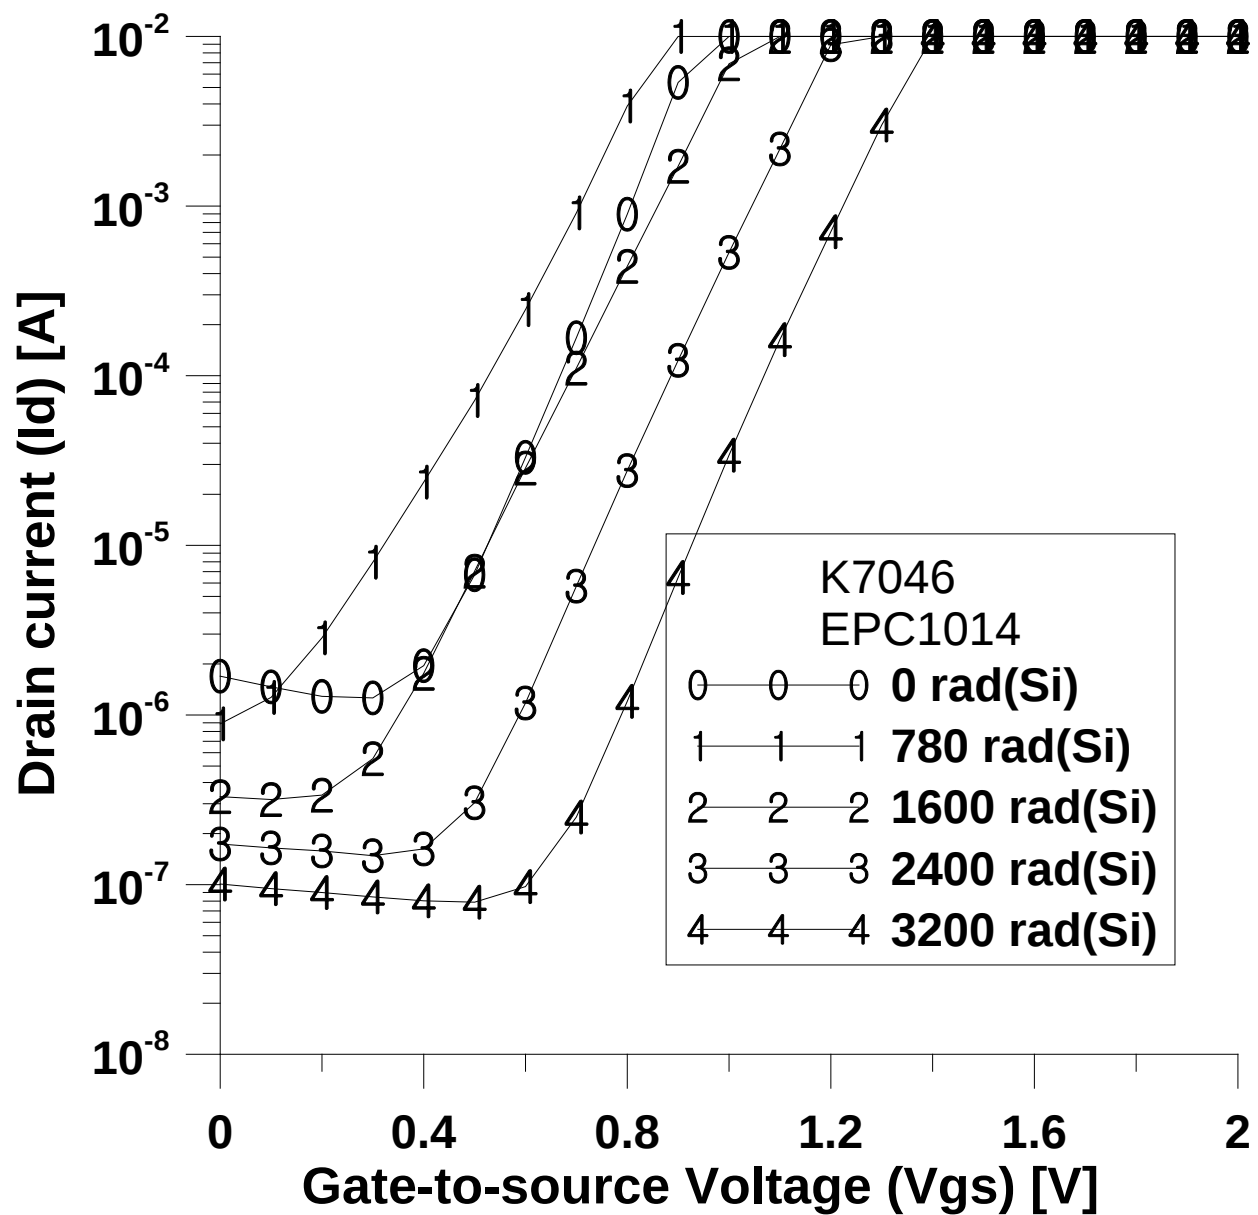
Fig. 9.13 and 9.14 present part K7046, EPC1014. Despite no drain leakage, the  $V_{th}$  and Gm are affected.

**Figure 1.1-1.** Heavy ion response of the EPC1014 40V/10A. Ion flux was  $3E4 \text{ cm}^{-2}\text{-s}^{-1}$ . Red line is drain voltage; gate voltage is zero volts. Black line is drain current and green line is gate current.

Figure 1.1-1. Effect of heavy ion radiation on the transfer curve K7046. Drain voltage was 10 V.
